## Worker falls from ladder when gutter hits high-voltage line

### Notice of Incident information

Number: 2006114550142

Core activity: Gutter installation

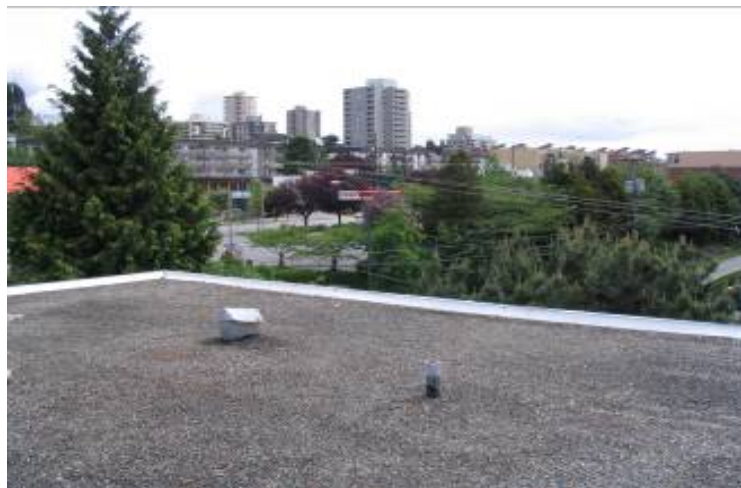
Three workers were installing new roof gutters on a three-storey apartment building. Two of the workers were on the roof, and the third was on an extension ladder. The three workers were lifting a 56-foot section of gutter onto the roof. Because of the gutter's length, the top end protruded above the edge of the roof, while the lower end came to rest on the edge of the roof. As the worker on the ladder lifted the lower end of the gutter, the top end contacted the inboard conductor of a high-voltage circuit. On electrical contact, the worker on the ladder fell 22 feet onto a concrete patio. The worker later died of his injuries.
